CIMFP Exhibit P-03005

T 450 659 8921 F 450 659 3371 www.gealstom.com O/Ref: LTR-CD0504002-ALS-POM-0059 Y/Ref: NA Reply: Y Agreement No: CD0504-002 – HVdc Specialties at MF & CF Subject: GIS Building – Major Quality and Safety Issue - MFA

During the daily site visit on 19-Jan-2016, Company and CWE observed the following, further to the formwork removal from the bottom of the top slab and P1 columns at grid line 15 & 16 (Attachment 1 – Pictures of defects):

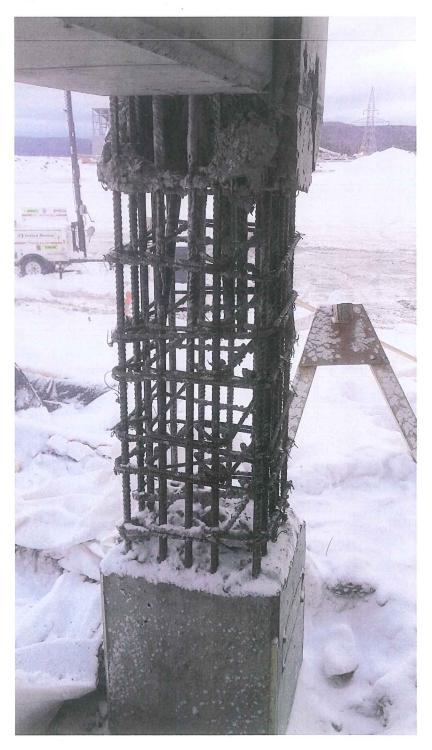
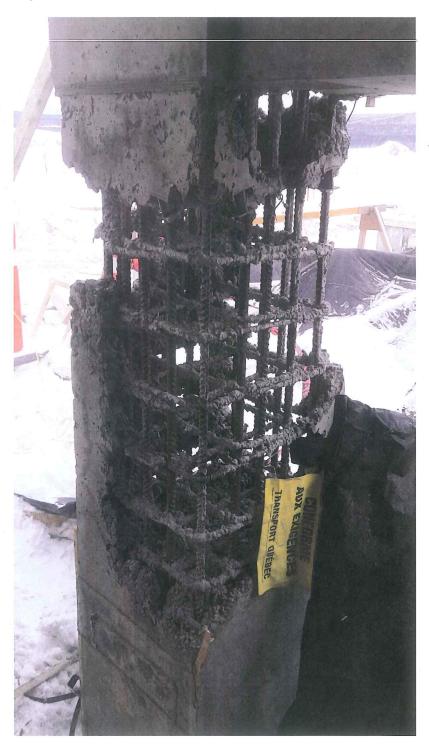
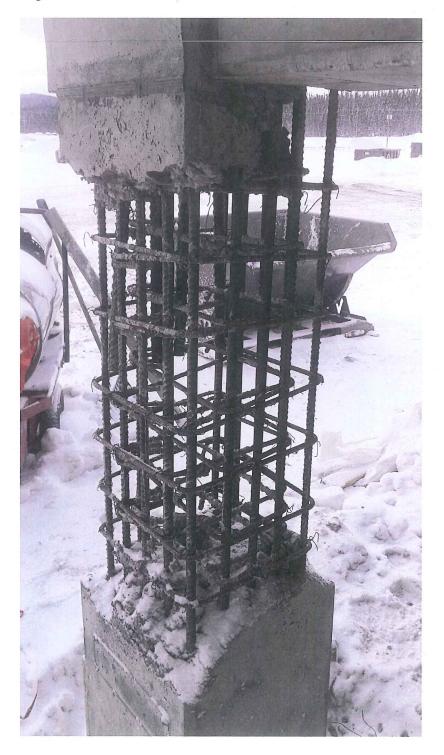
- CWC Subcontractor 's personnel (FOX) were working between grid lines 8 & 9 and in the meantime they also removed the formwork off the P 1 columns at grid lines 15 & 16, axis A, B & C
- After the forms were removed from these columns, it was discovered that three of the six got missed during the pour, 15, 16 axis A & 16 on axis C.
- Three columns were found to be hollow; the concrete did not pass through the beam and slab rebar.
- Further to the stripping of the GIS Building slab and beams, multiple defects have been noticed (Attachment 1 Pictures of defects)

A – Safety Plan and methods to be submitted and approved before accessing to that area for any action.

B - A complete structural assessment plan and methods, to be submitted and approved, to ensure and to guarantee the quality of the works realized and also to provide the associated execution schedule. In that regard, CWE is expecting very thorough and well documented plans to ensure that all aspects are fully addressed such as all the work to be witness and inspected, final work inspection assessment

C – Detailed NCR Report including, but not limited to:

- Root Causes Analysis
- Immediate actions to secure the area
- Entire Remediation process
- Corrective actions,

- Preventive actions enclosing actions to ensure not to repeat the situation,
