### Final Engineering Assessment Report of Draft Tube 2 Formwork/Falsework Failure

This document examines the Draft Tube 2 formwork/falsework failure that occurred May 29, 2016 on the Lower Churchill Project. ILF Consultants Inc. (ILF) has performed field inspections, reviewed design and fabrication documents, care and preservation practices, and erection and inspection documentation in an effort to identify the cause of failure.

On May 29, 2016, the timber formwork and falsework supporting concrete pour D2ESB-03 in Draft Tube 2 (DT2) failed nearing completion of the 530 cubic meter pour. On May 30, 2016, Newfoundland and Labrador Occupational Health and Safety (OHS) issued Stop Work Order #0671924-01. This effectively stopped all concrete work in the powerhouse until the falsework and formwork systems were evaluated by a Structural Professional Engineer (P.Eng.) licensed to practice in the Province.

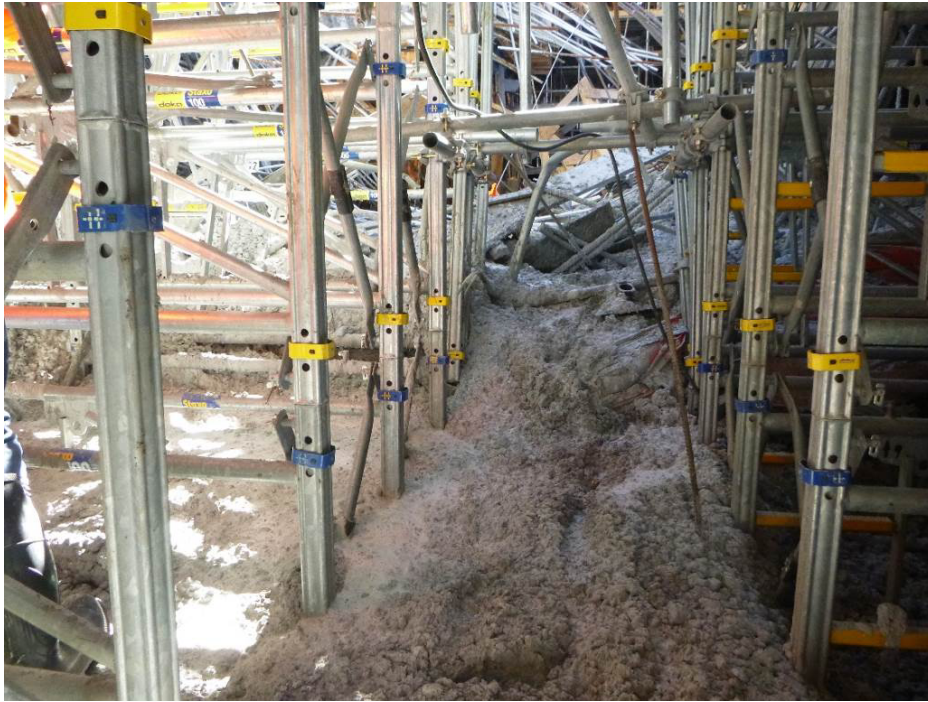
Figure 10: DT 2 south outlet looking upstream (west) into failure area

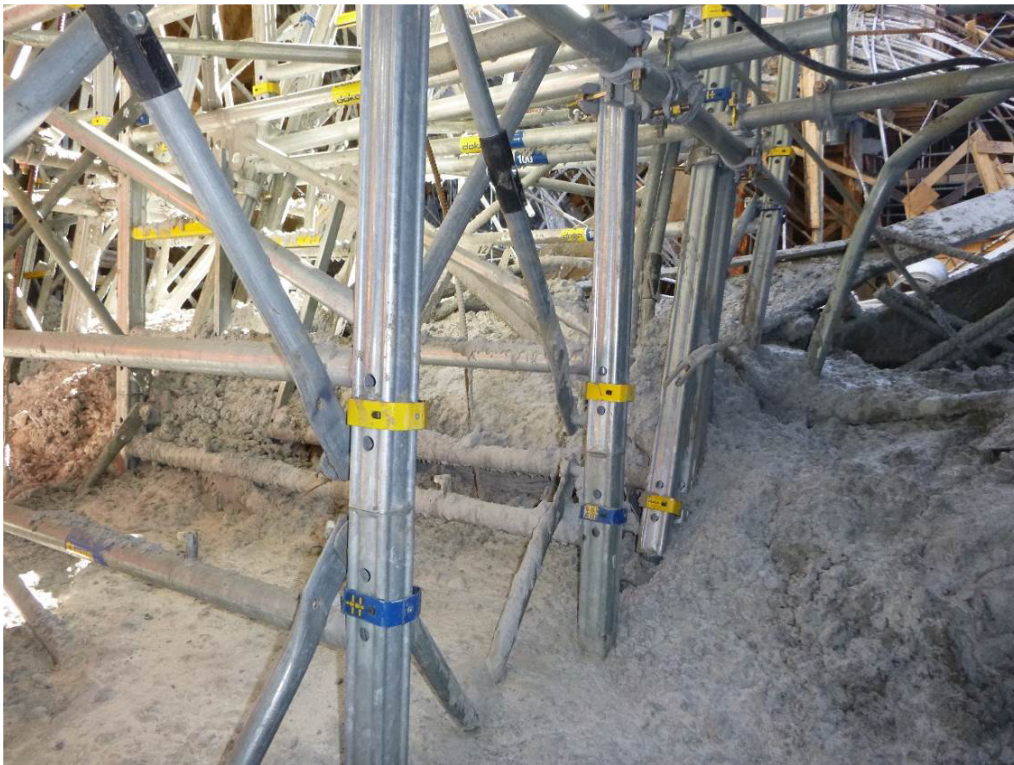
Figure 11: DT2 south outlet looking west-southwest into failure area

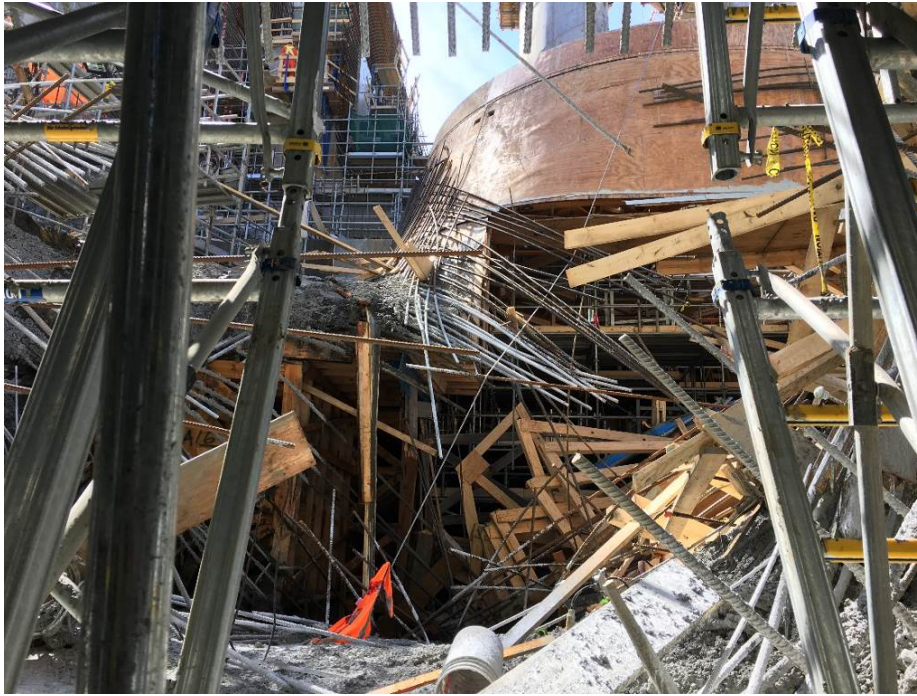
Figure 12: DT2 failure area looking west from northern portion of DT2 south outlet

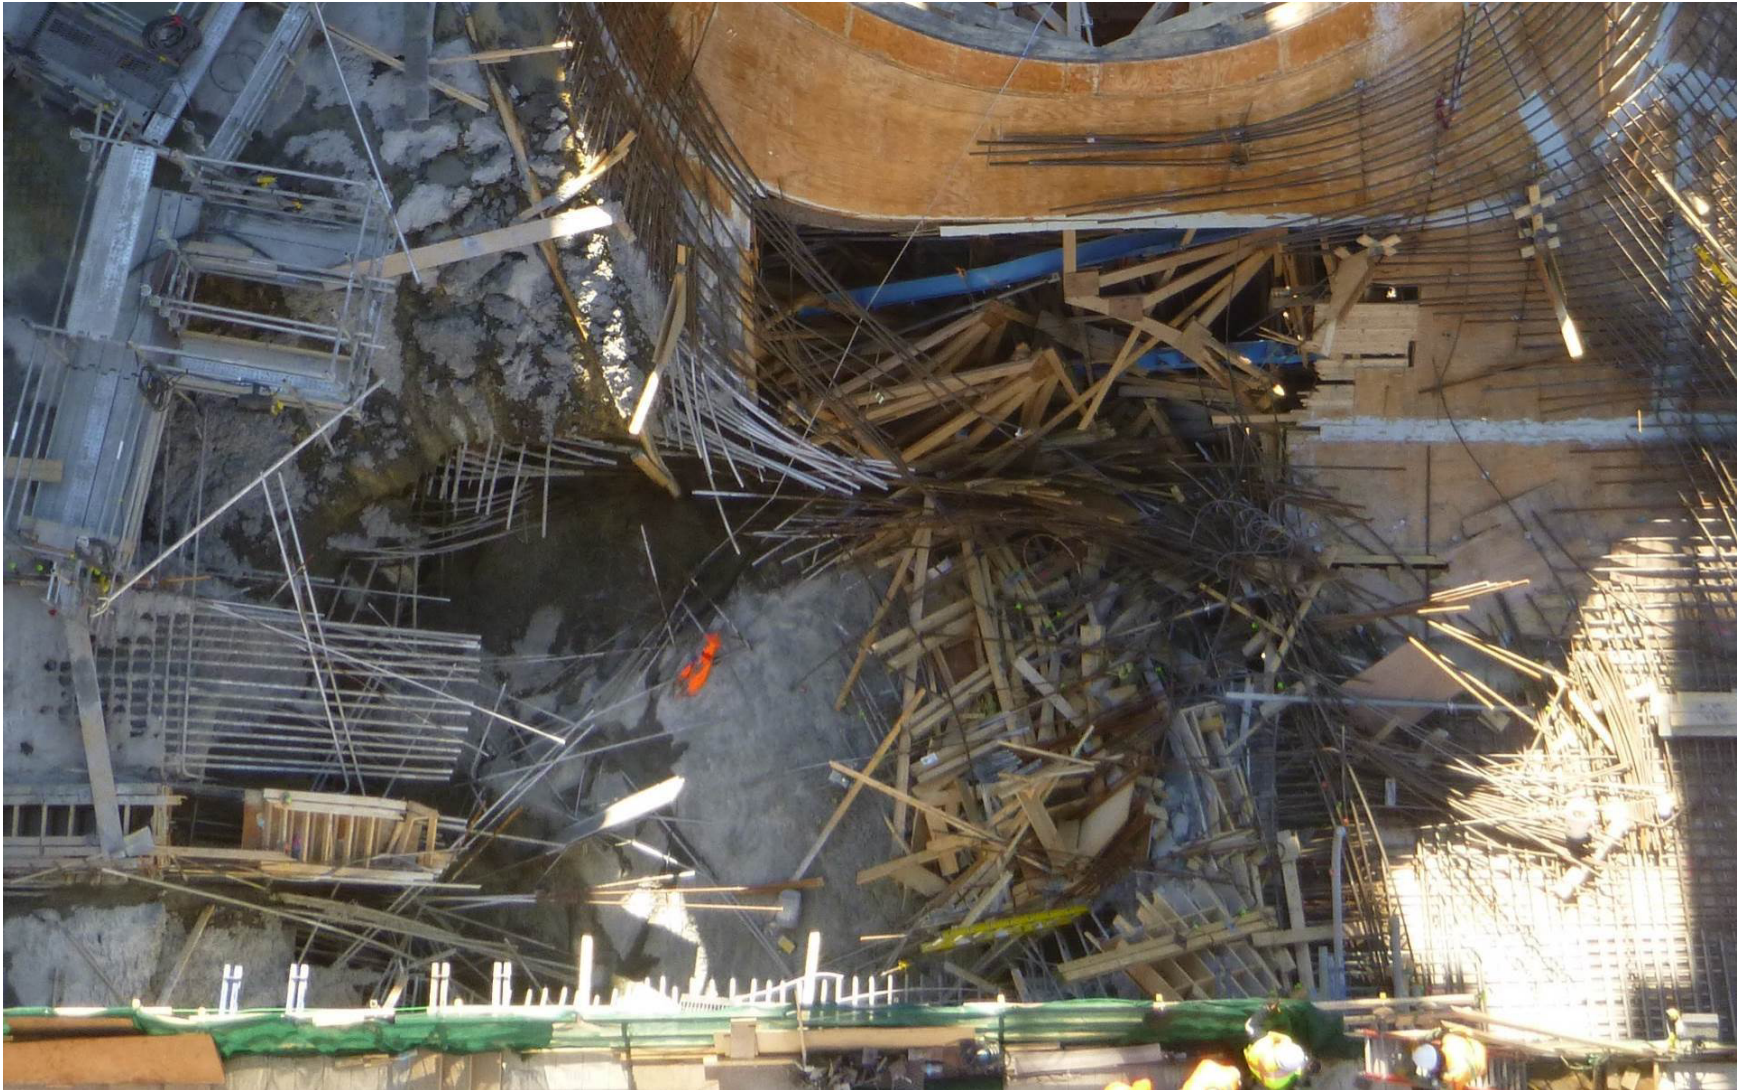
Additional visual inspections in the DT 2 formwork/false work incident area were conducted by man basket on June 4 and June 11, 2016. Visible tower leg members had signs of weathering and were clearly darkened and grey in color compared to adjacent formwork lumber. It was observed and recorded that several of the upstream legs of towers C3 and C4 had potential indication of inadequate nailing of the 2x10's forming the legs. In some instances, plies were separated. See Figure 7 for Falsework tower naming convention. There were visible indications that the bearing surface on top of the Falsework towers was not uniform, as shown by the column members' end grain being compressed on some 2x10 members but not on others, attributable to the lack of bearing plate and uneven tower leg bearing surface. There was no evidence of a bearing plate being installed at the top of tower legs in the rubble or on remaining erect towers. It was deemed that a ground level inspection would be required to further assess the extent of the deficiencies and damage to the Falsework towers and formwork.

Figure 15: DT2 failure area from man basket

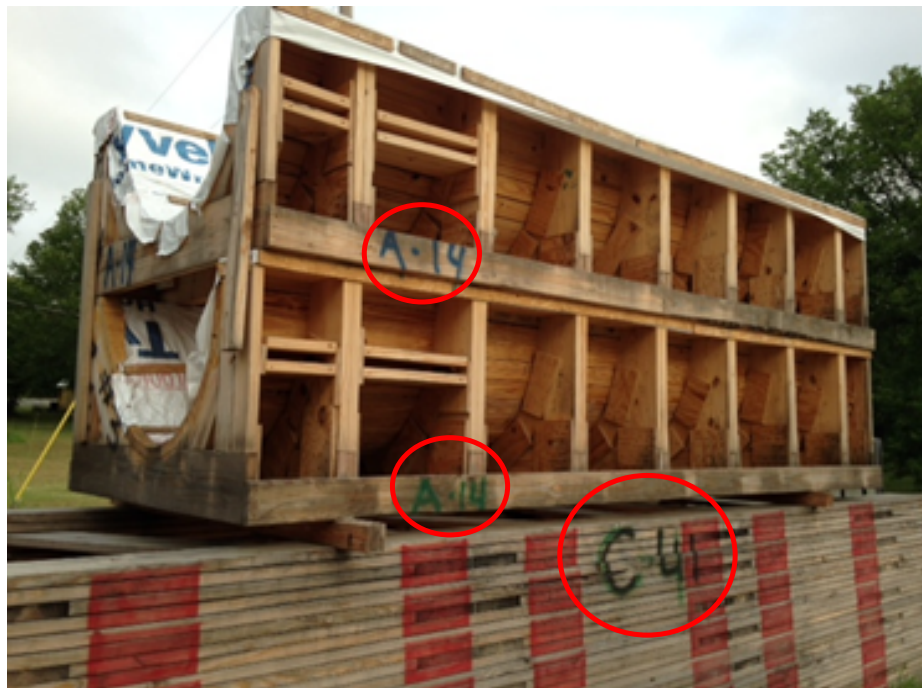
Figure 22: Formwork and falsework with multiple color markings "C41" and "A14" at CEI's facility

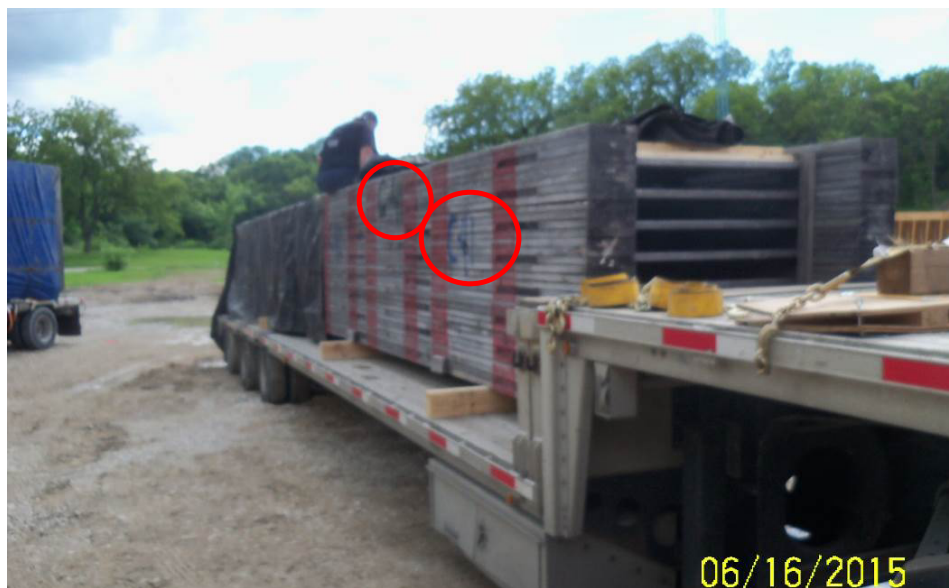
Figure 23: Falsework with multiple color markings "C41" at CEI's facility

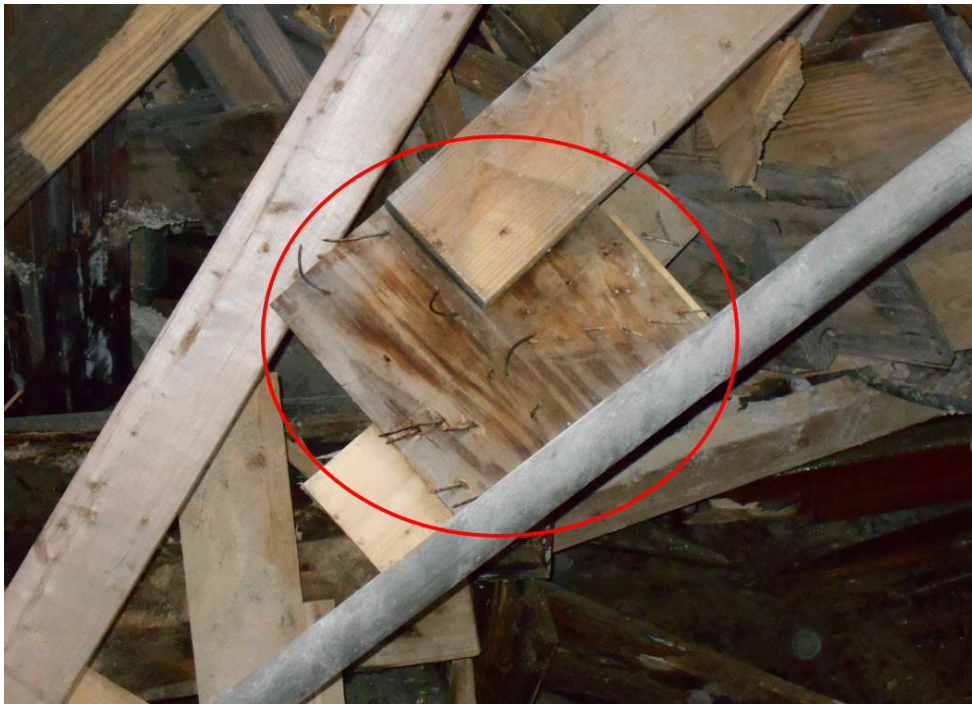
- Inadequate nailing of splice plates to falsework tower legs was observed. Nailing patterns were random and did not adhere to the typical splice plate detail shown on drawing CEI fabrication drawing MFA-AT-SD-3310-CS-D04-0001-01\_C1. See Figure 25 and Figure 26.

- Splice plates used to join falsework towers were inadequately nailed to tower legs. See Figure 25 and Figure 26. Reference MFA-AT-SD-3310-CS-D04-0001-01 within Appendix J for splice plate dimensions and nailing requirements.

Figure 26: Splice plate pulled away from tower leg

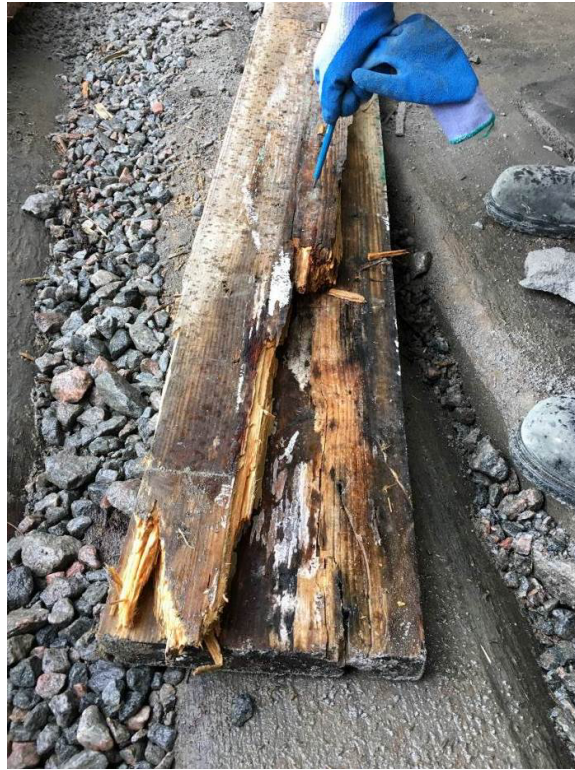
Figure 38: Bottom of Tower Leg obtained from DT2, Tower C3

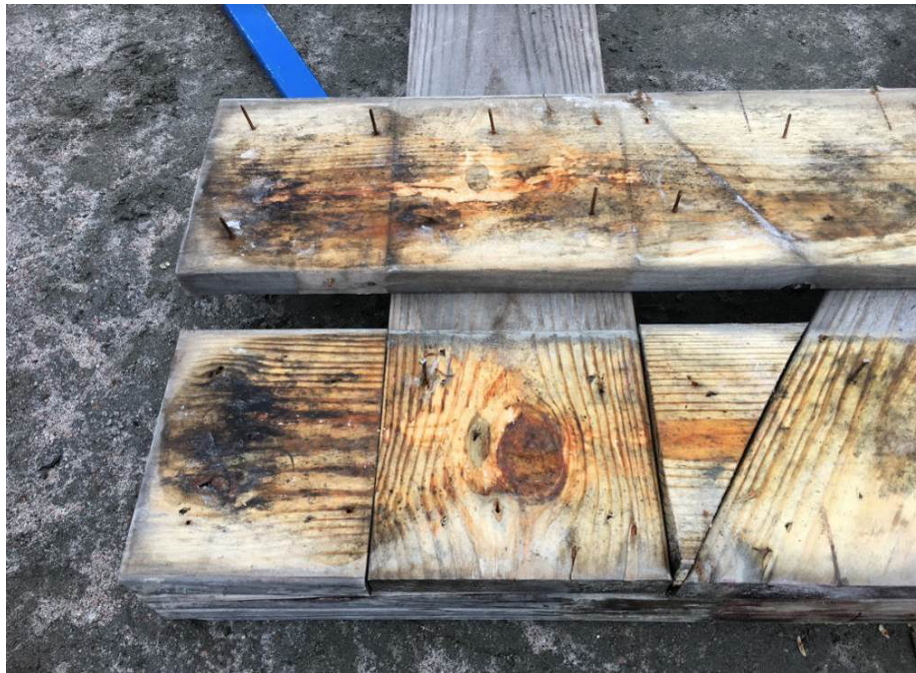
In order to determine typical as-built towers, as fabricated by CEI, Draft Tube 3 falsework tower C3 was disassembled, exposing the penetrations in the 2nd layer of the tower legs, as shown in Figure 42 and Figure 43. This layer contains the internal bracing that does not conform to CSA and NDS guidelines. ILF also observed saw kerfs and gaps between tower leg members in many tower sections, which reduces effective tower section areas.

Figure 42: Disassembled Leg at Bracing from DT3

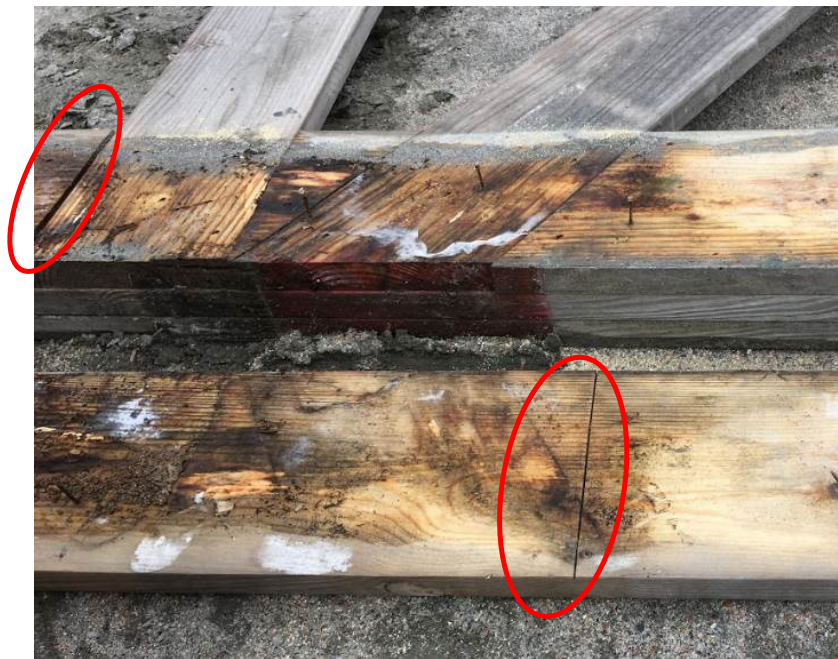
- ii. Numerous instances of saw kerfs and gaps in members of falsework tower legs were observed. Both of these defects reduce allowable capacity of structural members.

Figure 43: Gaps in Tower Leg Butt Joints (left) and saw kerfs (right) from DT3

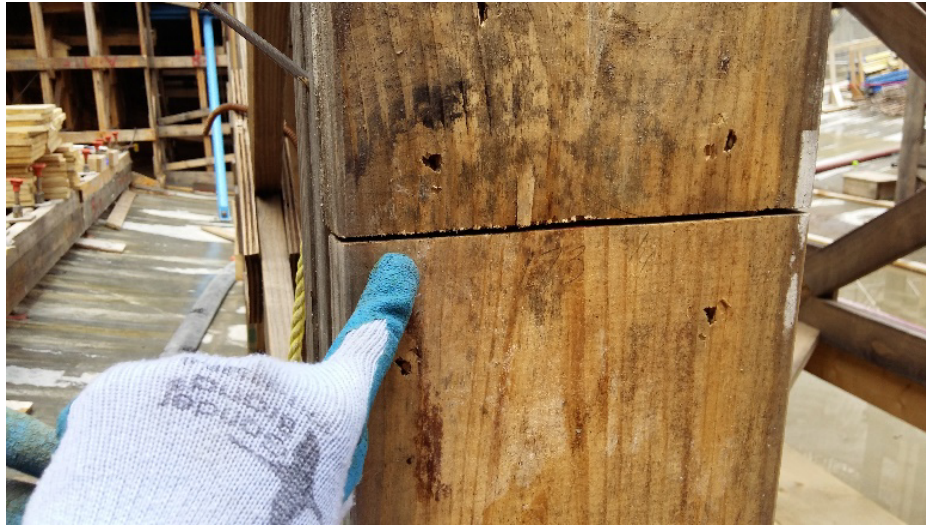
Figure 44: Gap in Tower Leg Butt Joint in DT3

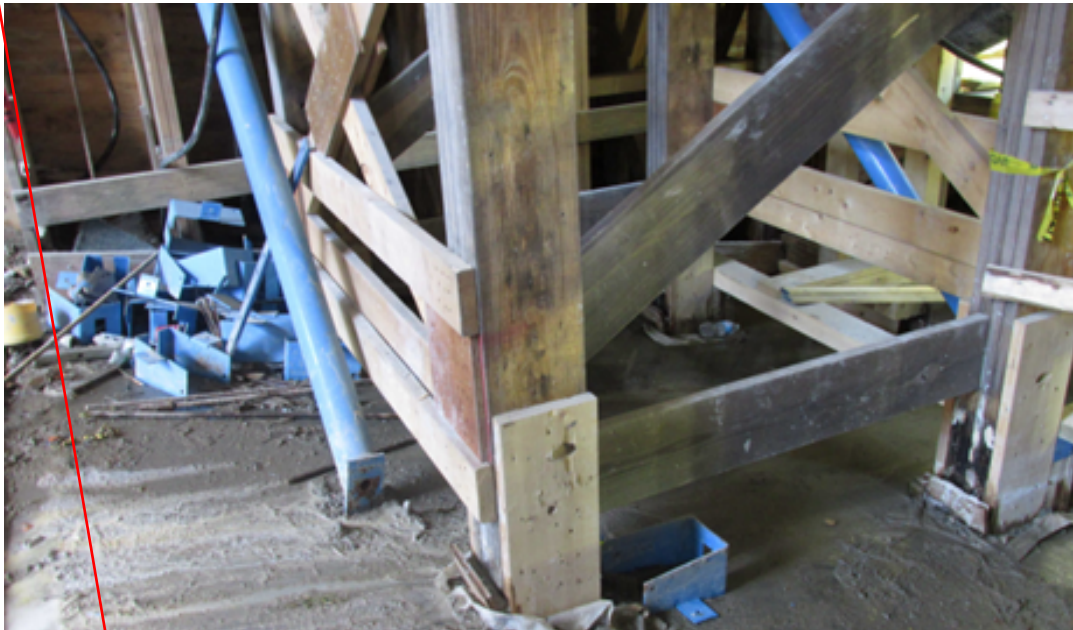
In Draft Tube 1, 14 of the 16 falsework towers did not use the anchorage detail indicated on drawings MFA-AT-SD-3310-CS-D04-0066-01 through MFA-AT-SD-3310-CS-D04-0066-06. An alternative detail consisting of a polyethylene sheet under a grout pad without anchorage to the concrete invert was utilized. The figure below shows Tower A6 in DT1 with the alternate tower grout pad and CEI designed column anchors uninstalled in the background. The alternate detail reduced sliding resistance of the columns, but was compensated for by additional bracing at the bottom of tower legs. Lateral movement at tower base was not observed in DT1. Based on observations in field, it is anticipated that the alternate anchorage was used in some of DT1 and all of DT's 2, 3, and 4. ILF was not able to identify use of the CEI designed "shoe" in the DT2 rubble and found examples of the alternate on all observed towers. Similarly, the alternate was exclusively observed in DT3 and DT4.

Figure 60: DT1: Uninstalled tower base anchors (blue steel clips) in foreground and piled in background. Alternate grout pad with form installed in foreground left and right.

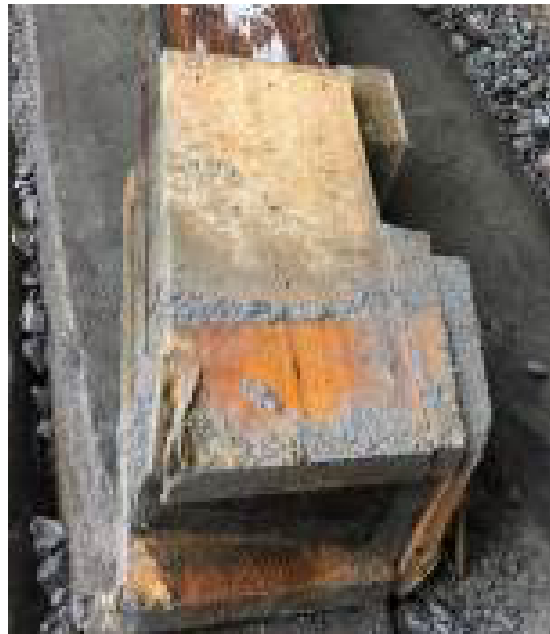
Figure 61: Alternate grout form at base of falsework tower leg. Recovered from Row C towers DT2

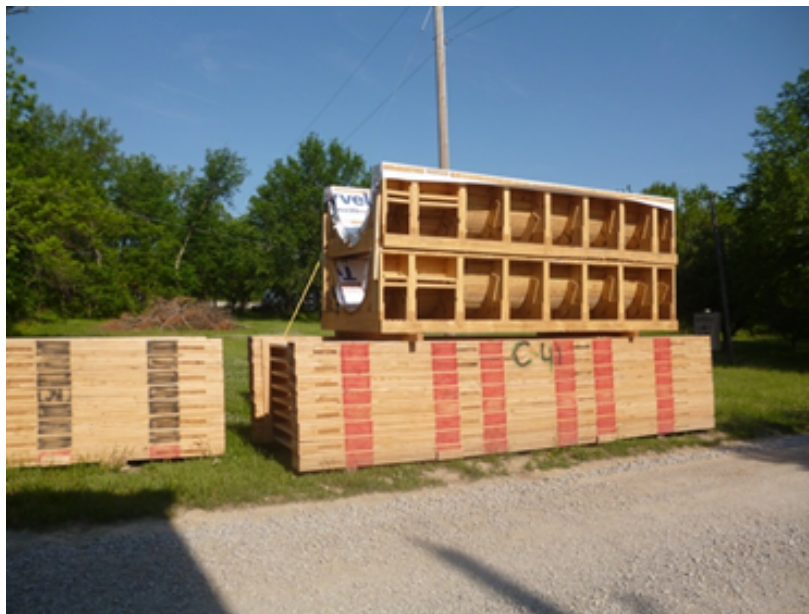
Standard practice of placing lath between layers of face-to-face lumber was not practiced by CEI, as shown in Figure 62 through Figure 66. The lumber marked "C41" are tower legs stored face-to-face, which does not promote air circulation between layers of tower legs. This practice can encourage damp conditions that are conducive to biological attack.

Figure 62: May 15, 2014. Formwork and falsework at CEI facility. Note fresh, unweathered wood.

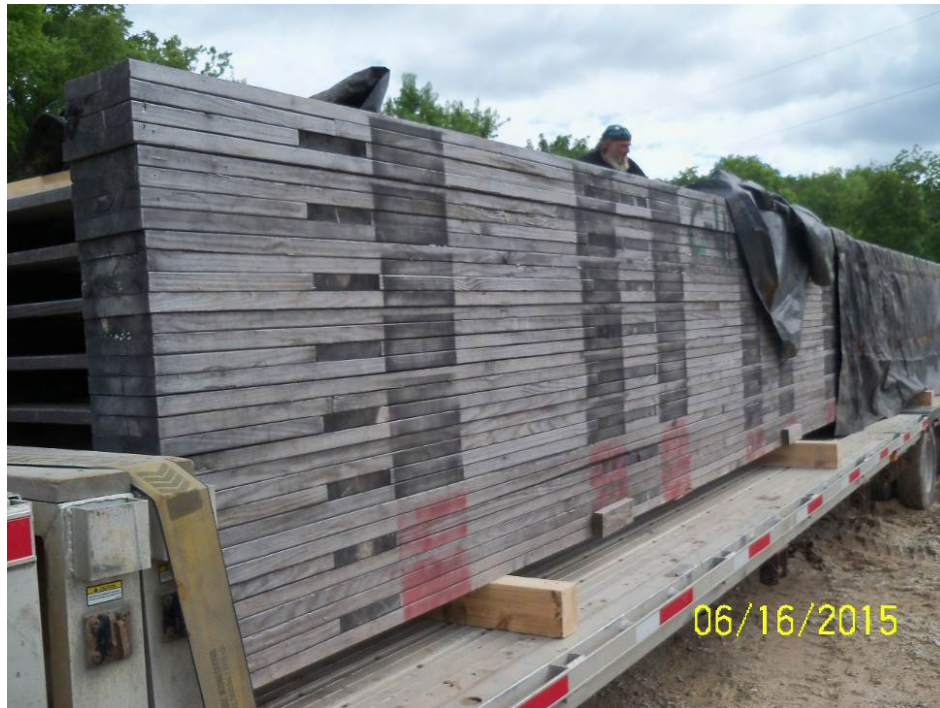
When viewing Figure 64 and Figure 65, reference Figure 62 and Figure 63, noting the progression of weathering over a 15 month period. Also reference Figure 29 in Section 3.3.3, which depicts the same black and green paint markings "C41". ILF believes the towers depicted in Figure 62 through Figure 66 were installed in DT2 at time of the collapse.

Figure 65: June 16, 2015 at CEI yard. Left hand view of falsework towers believed to be installed in DT2

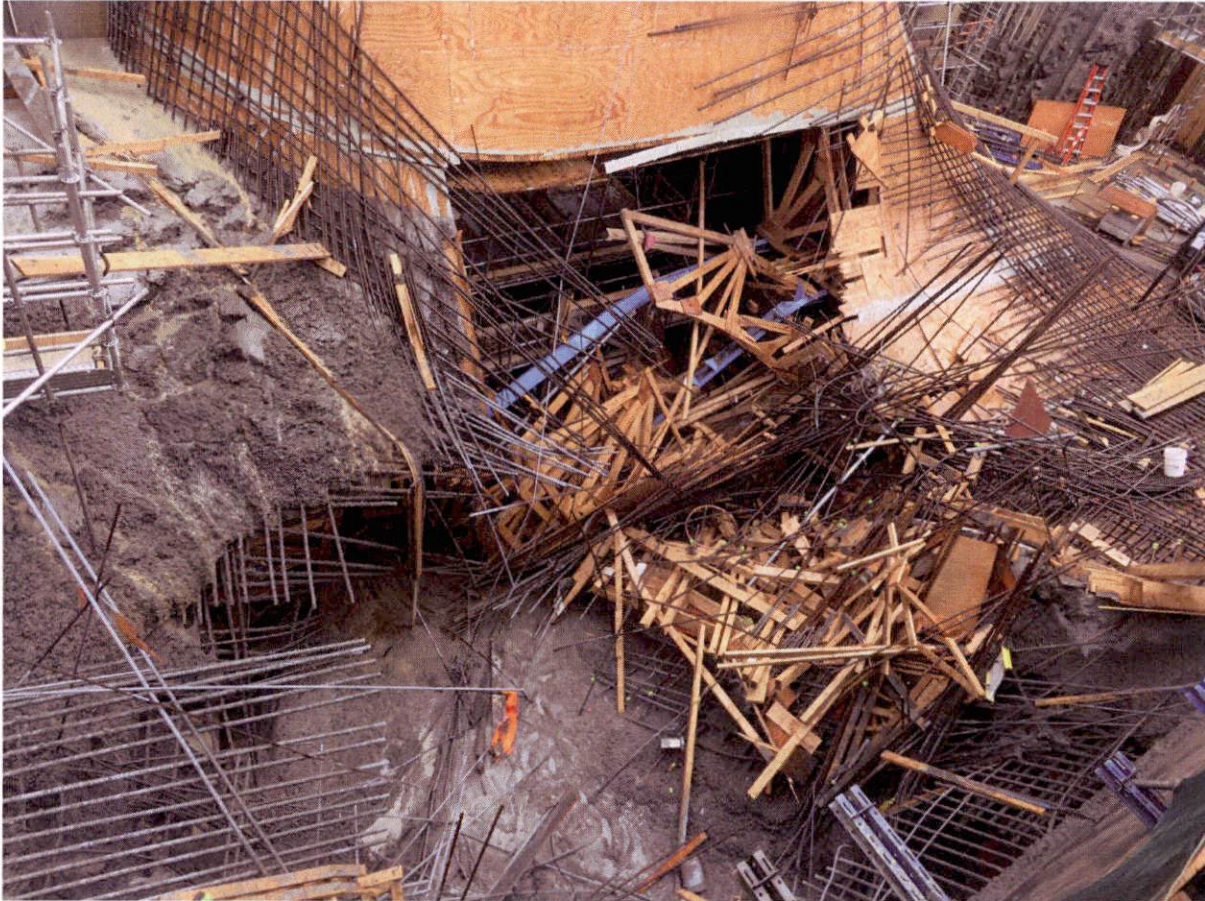
Figure 2: Unit 2 draft tube formwork collapse - view of SE corner of unit

The collapse was significant in that it damaged all lumber shoring towers directly underneath this section of concrete. The workers in the area were finishing the concrete on the gallery's floor when the falsework collapse. The collapse resulted in the workers falling directly into the freshly poured concrete where one worker was fully submerged.

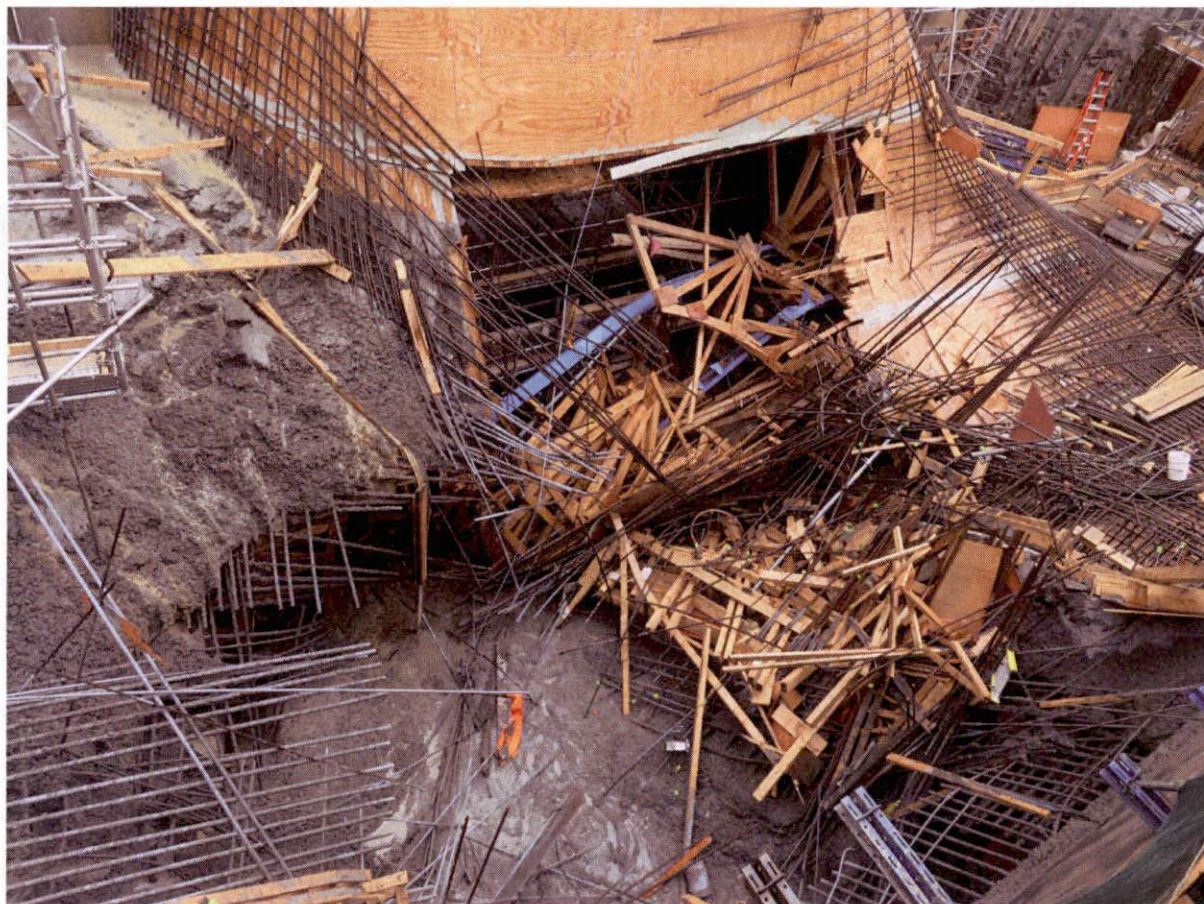
Unit 2 draft tube - View of South East corner of unit, looking below

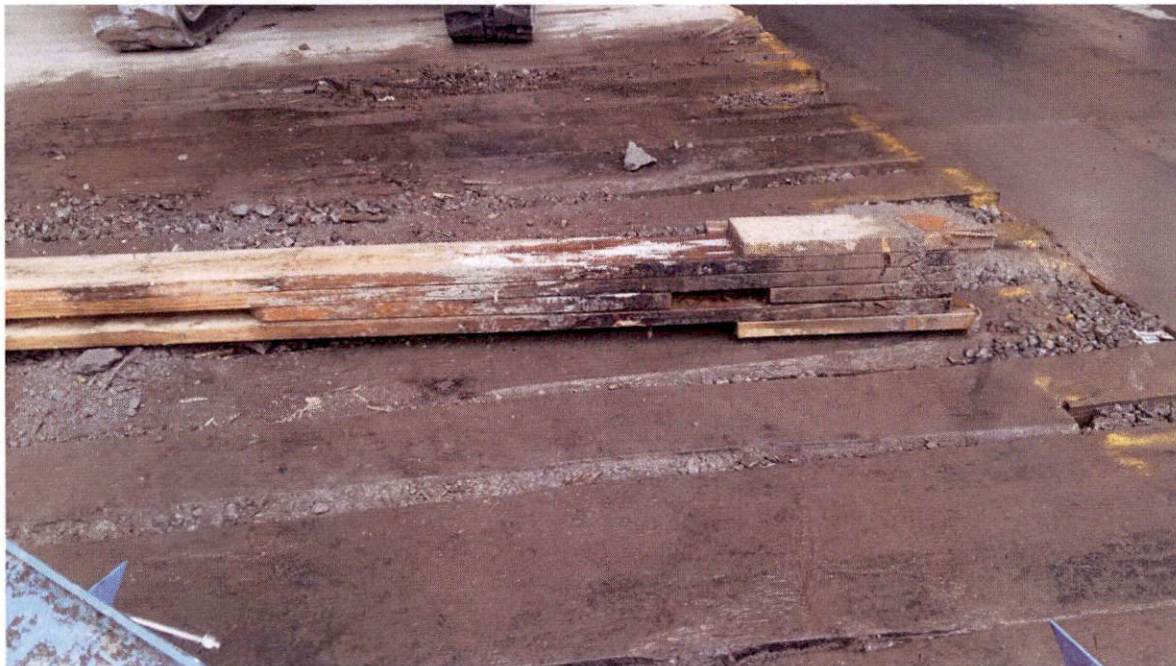
Unit 2 - Shoring Tower weathering

This report recommends the implementation of a temporary structure risk management and courageous safety leadership programs, the protection of wood structures against weathering, rigorous design reviews prior to construction, and rigorous daily checks of structures during construction and prior to loading.

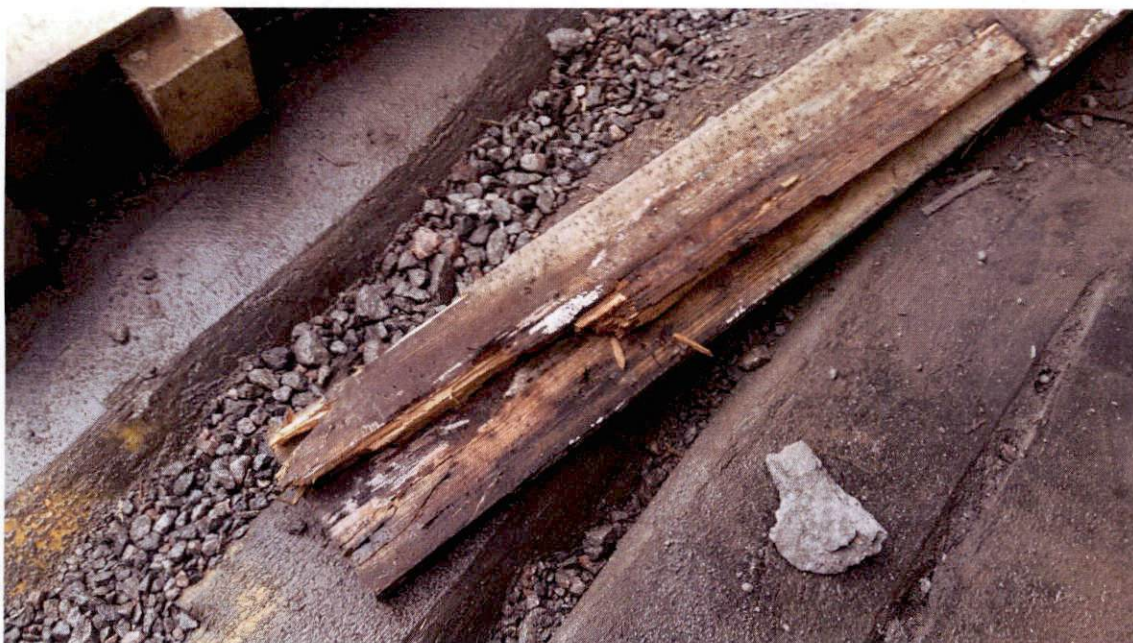
Unit 2 - Shoring tower rotten lumber

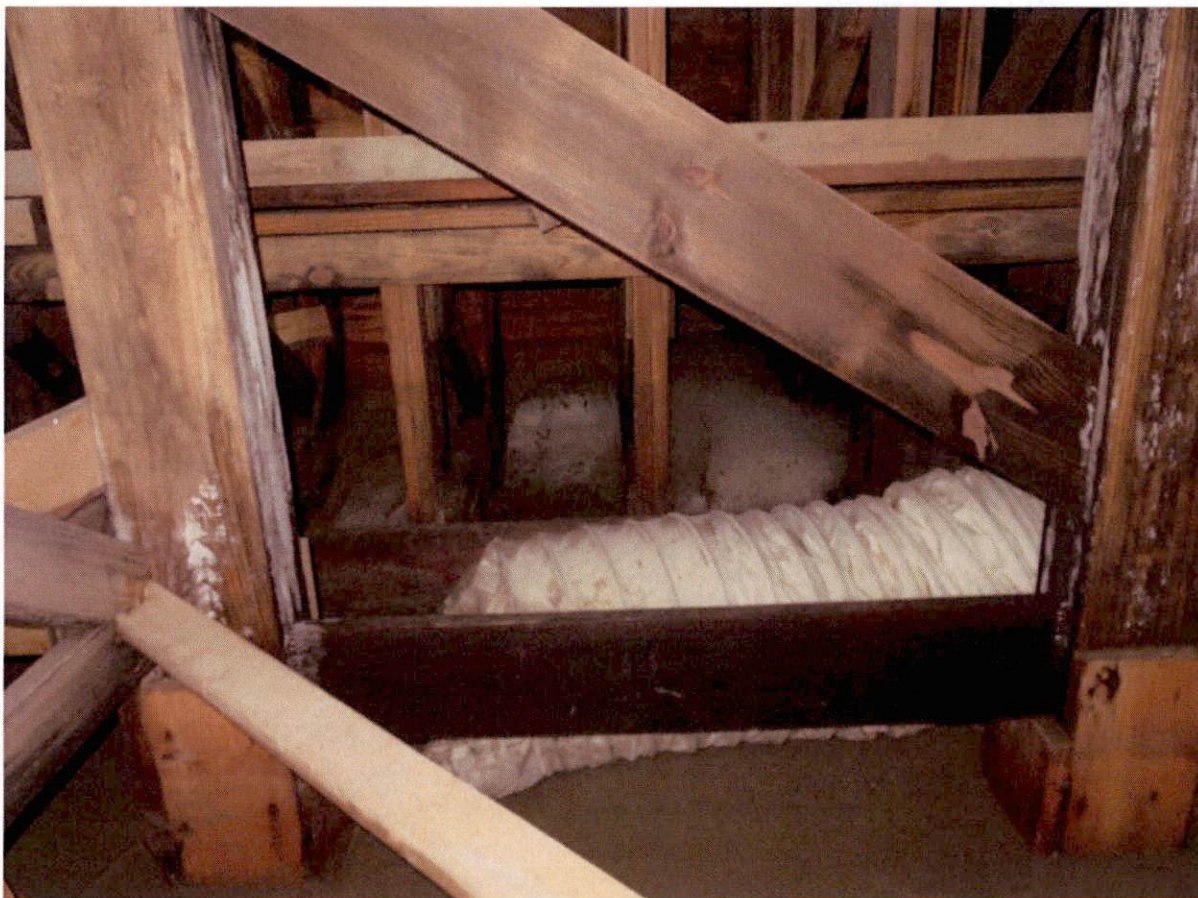
The formwork in the Unit 1 draft tube displayed evidence of exposure to high relative humidity, rain, and snow. The bottom of the formwork also displays evidence of having been submerged in water for a prolonged period of time. The evidence observed includes:

- A clear water line mark approximately 3 feet above the ground
- Ice built up between the ribs (observed in June)
- Wood appeared to be decayed with fungus and mushrooms growing on the lumber

Unit 1 - Fungi growth on lumber of tower B6

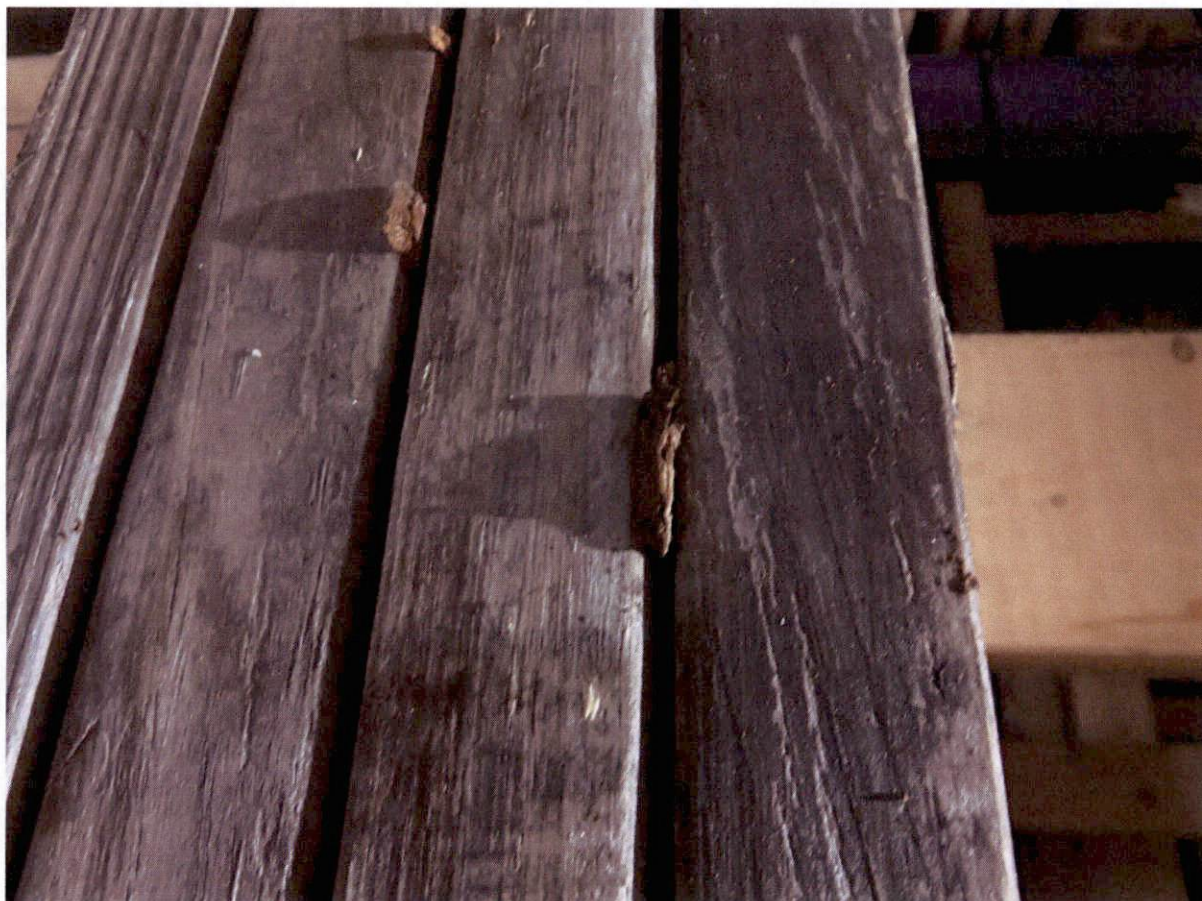
Unit 1 – Mushroom growth on tower B3

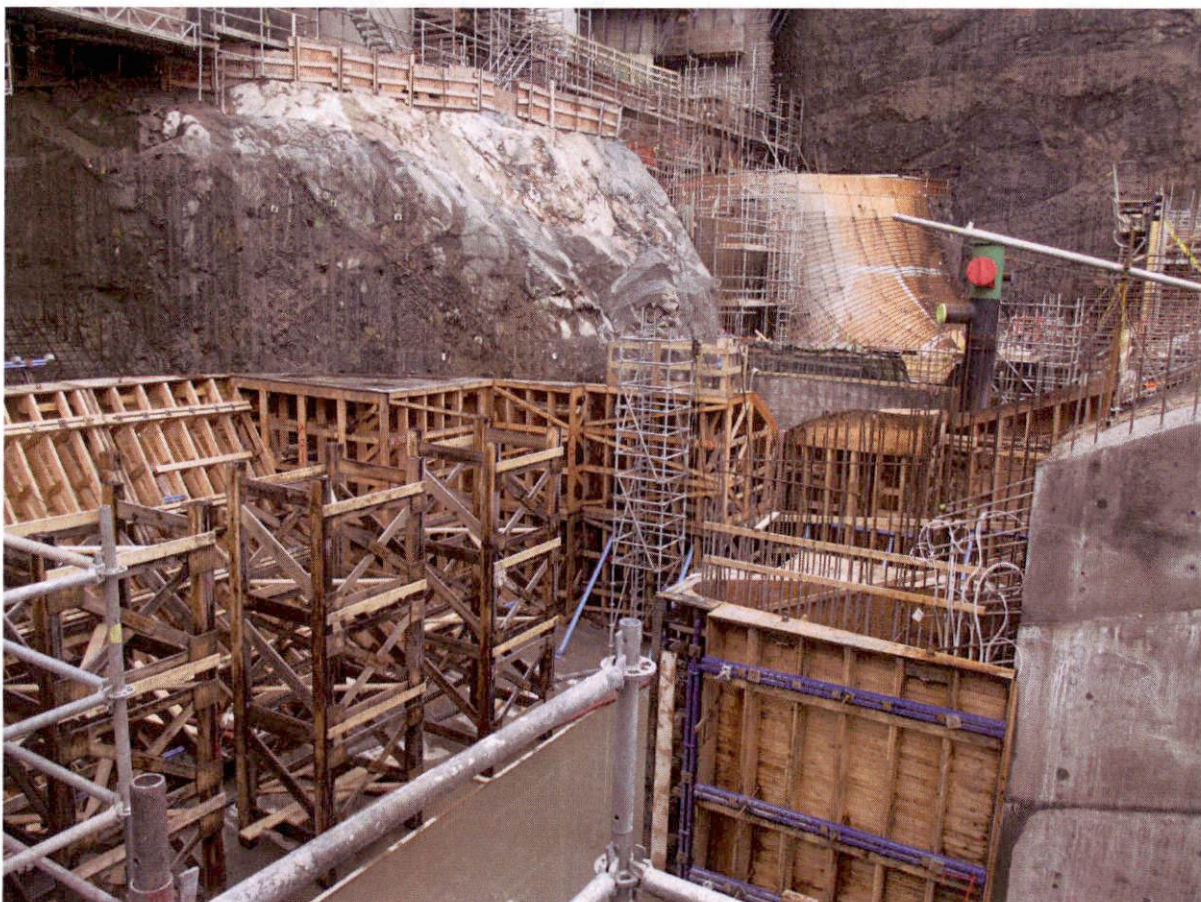
The towers displayed evidence of severe weathering. The lumber planks were dark grey / black in colour due to the weathering. This is indicative of the towers having been damaged before installation. It is also an indication that the wood structures were not well protected in storage between fabrication and installation.

Unit 3 - Installed shoring tower weathering

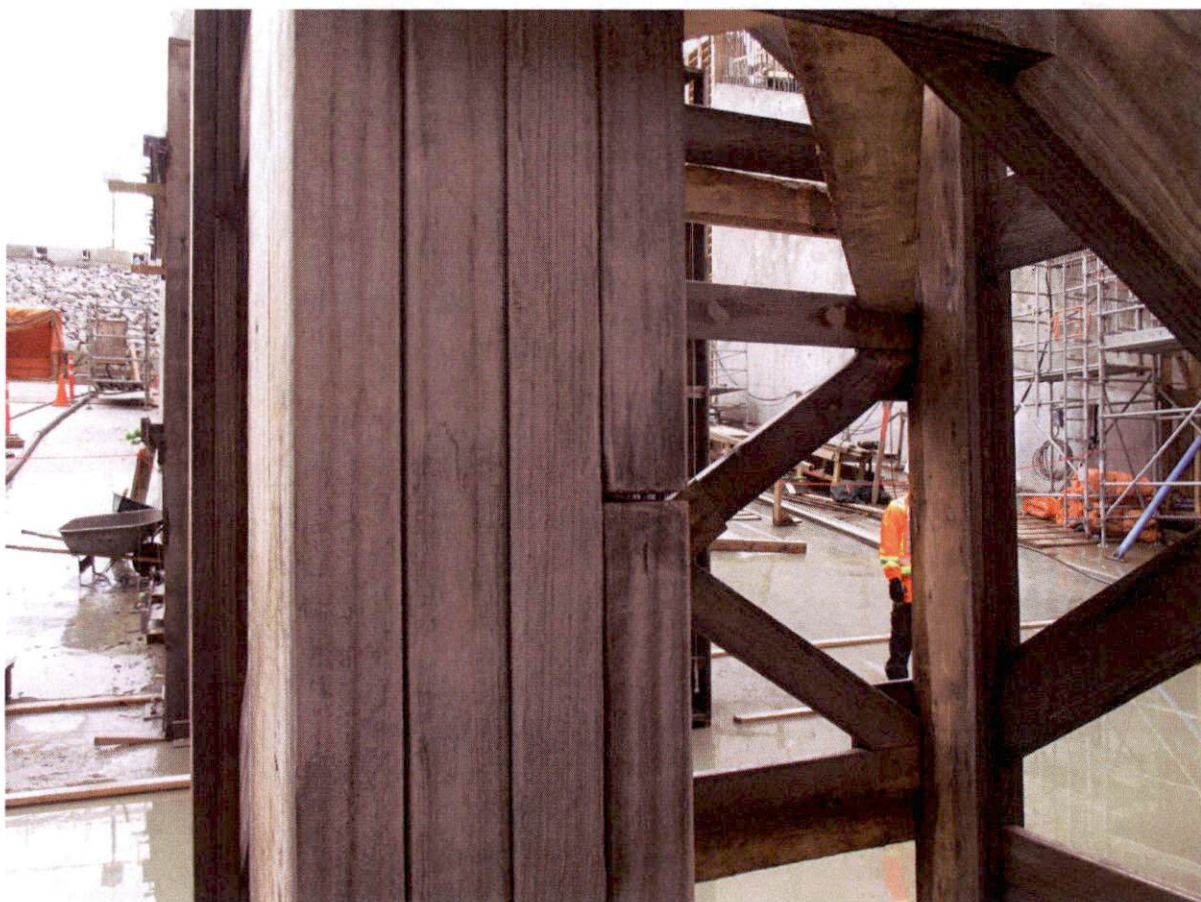
Unit 3 - Built-up tower with a gap between two planks

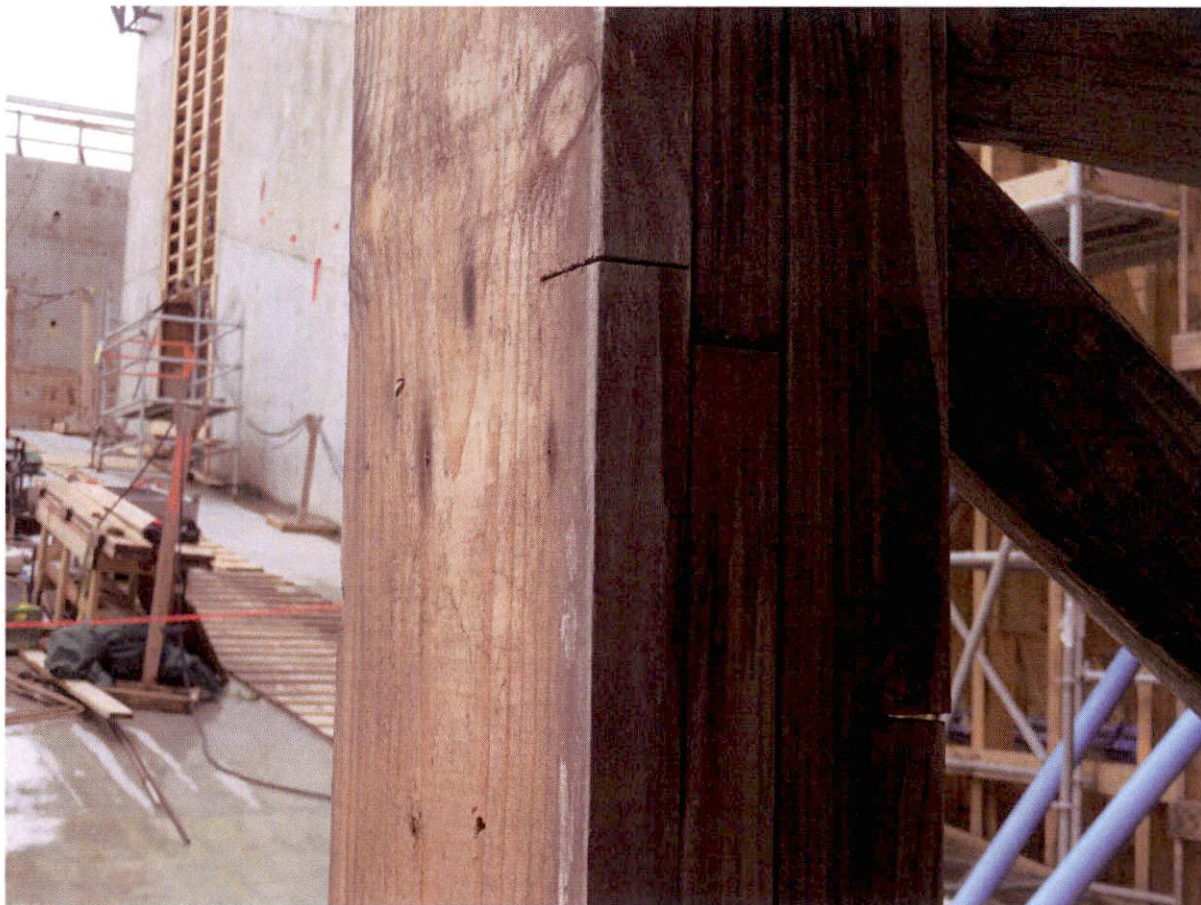
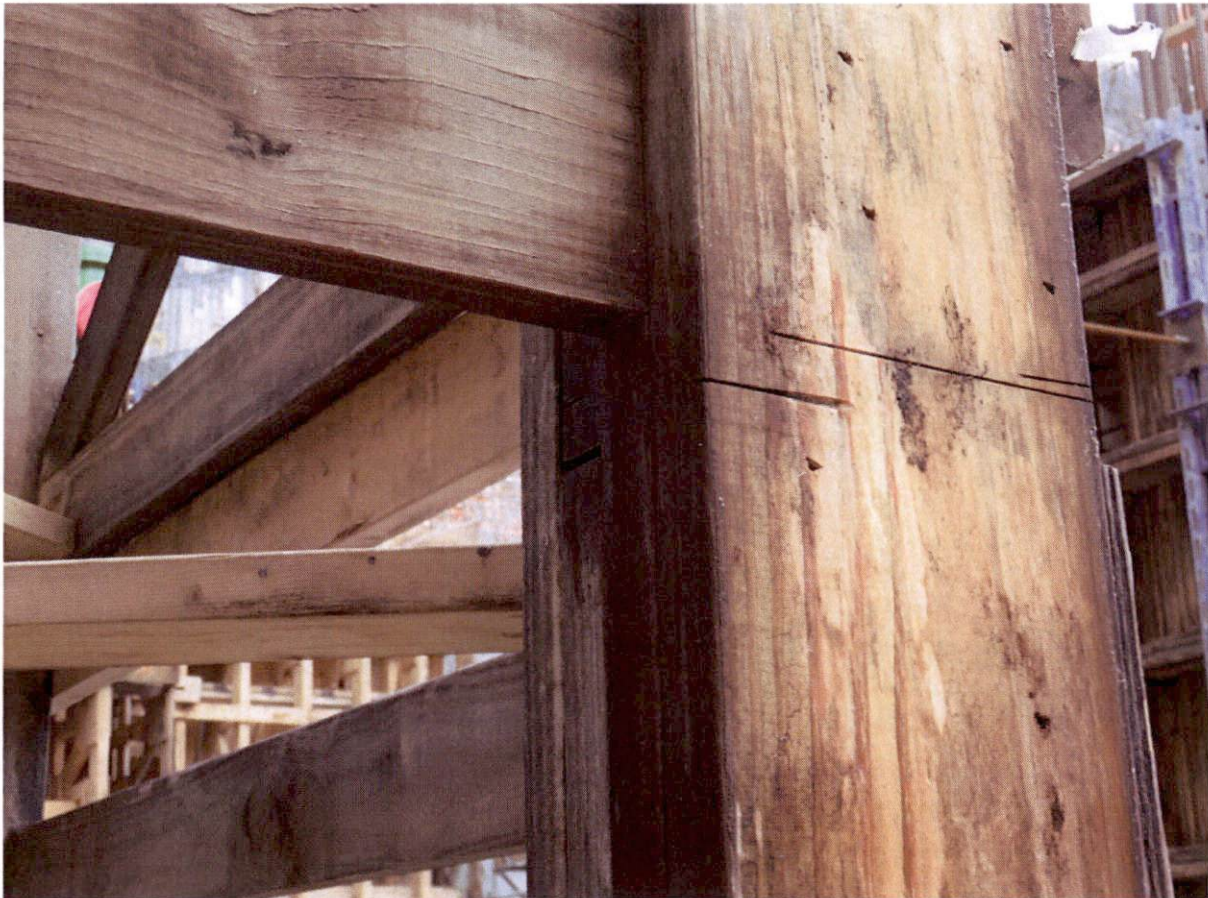
Unit 3 - Saw cut mark in lumber
