### Final Engineering Assessment Report of Draft Tube 2 Formwork/Falsework Failure

This document examines the Draft Tube 2 formwork/falsework failure that occurred May 29, 2016 on the Lower Churchill Project. ILF Consultants Inc. (ILF) has performed field inspections, reviewed design and fabrication documents, care and preservation practices, and erection and inspection documentation in an effort to identify the cause of failure.

On May 29, 2016, the timber formwork and falsework supporting concrete pour D2ESB-03 in Draft Tube 2 (DT2) failed nearing completion of the 530 cubic meter pour. On May 30, 2016, Newfoundland and Labrador Occupational Health and Safety (OHS) issued Stop Work Order #0671924-01. This effectively stopped all concrete work in the powerhouse until the falsework and formwork systems were evaluated by a Structural Professional Engineer (P.Eng.) licensed to practice in the Province.

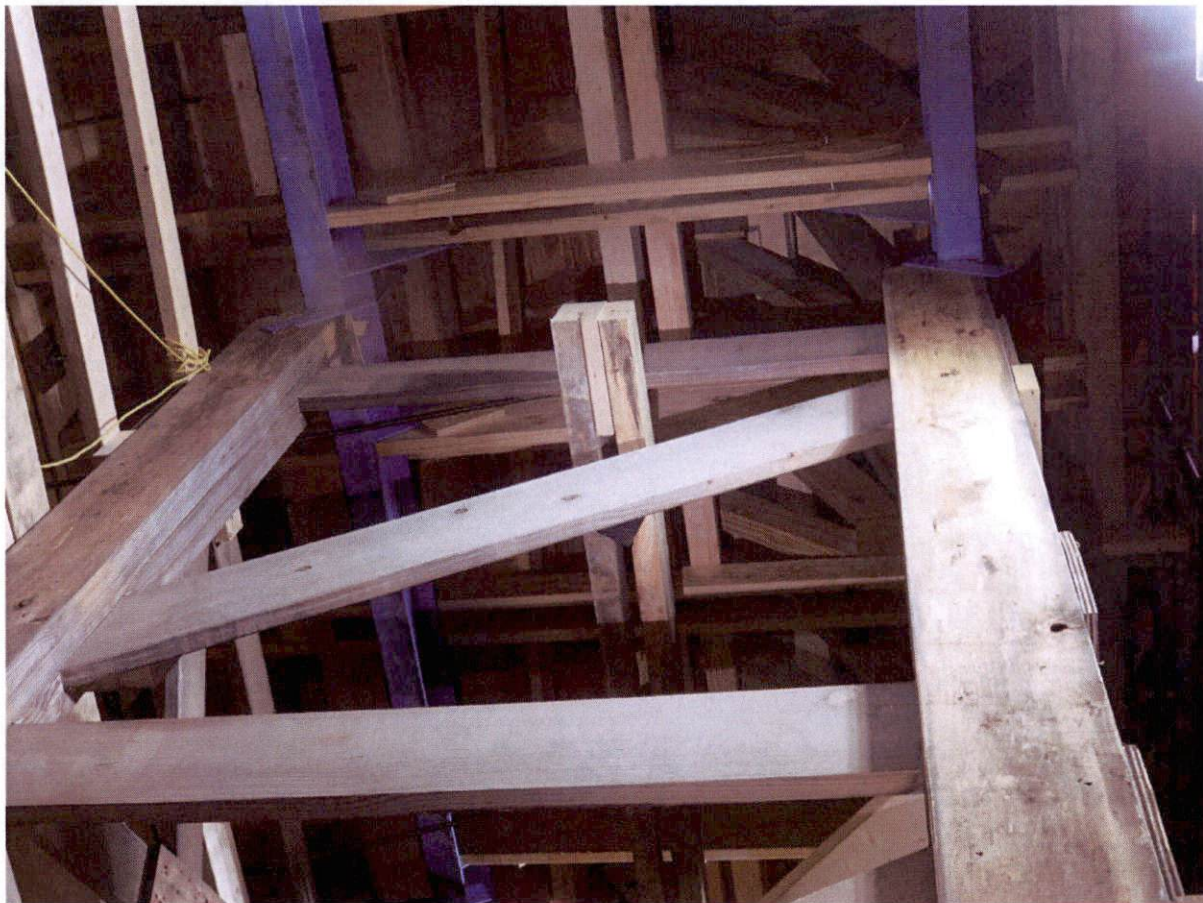
Unit 4 - Tower misaligned with steel beam

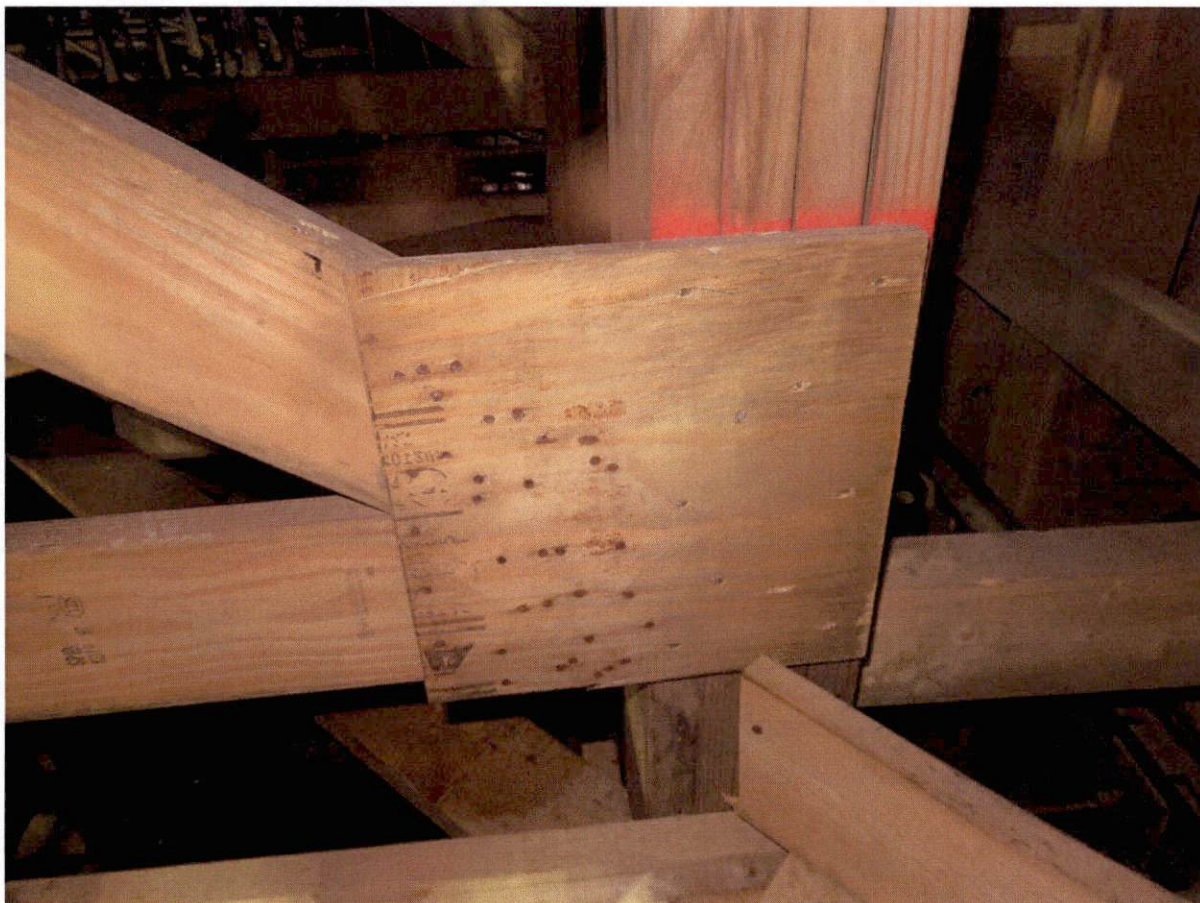
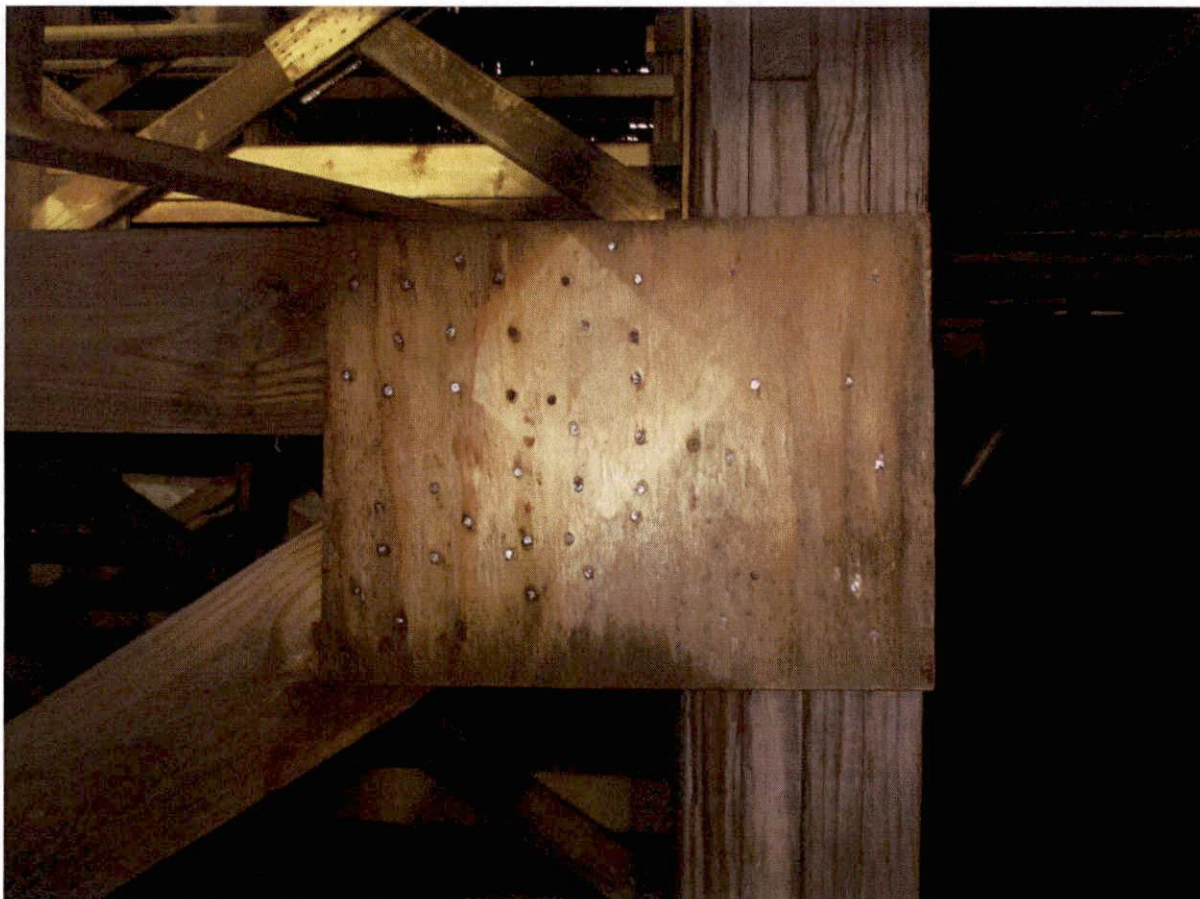
Unit 4 - Tower brace installed on site – Insufficiently nailed

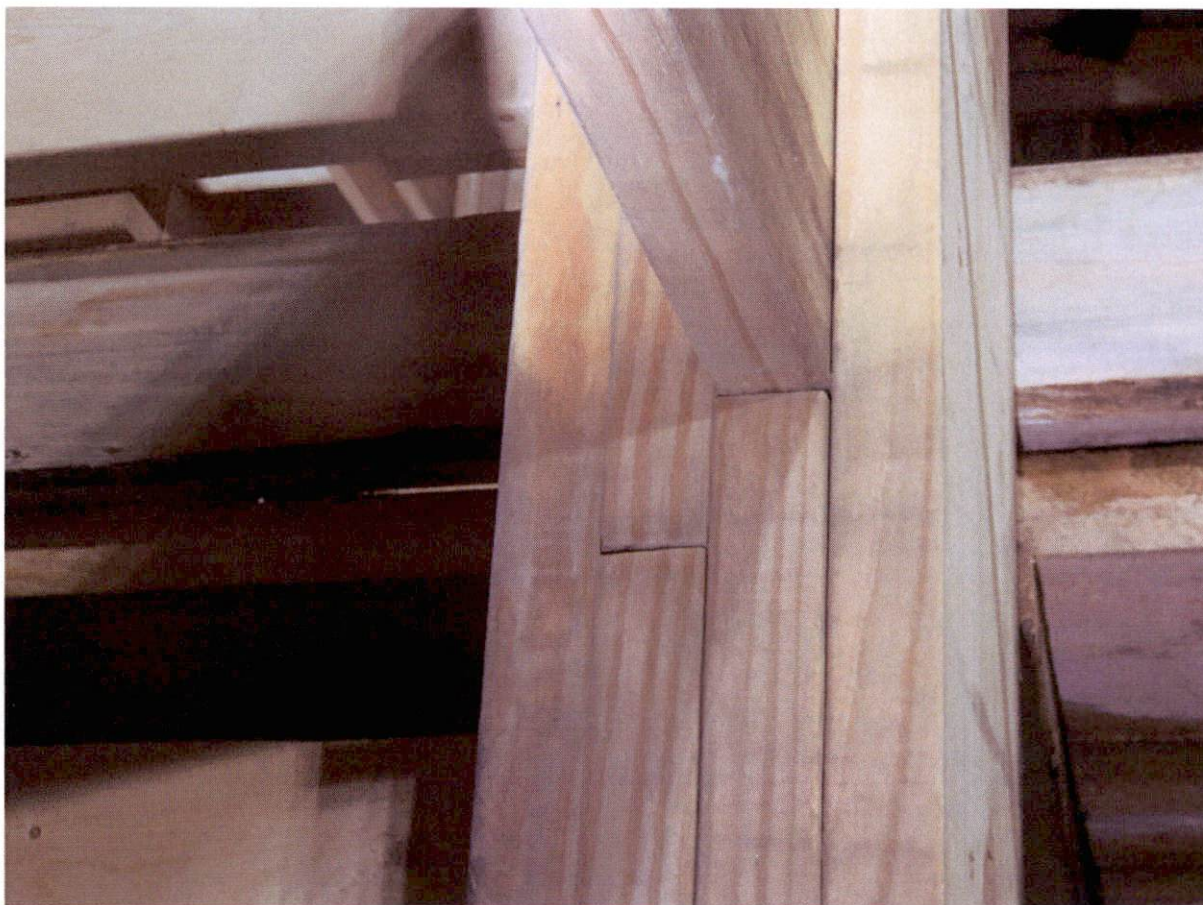
Unit 4 - Inappropriate location for built-up post joint

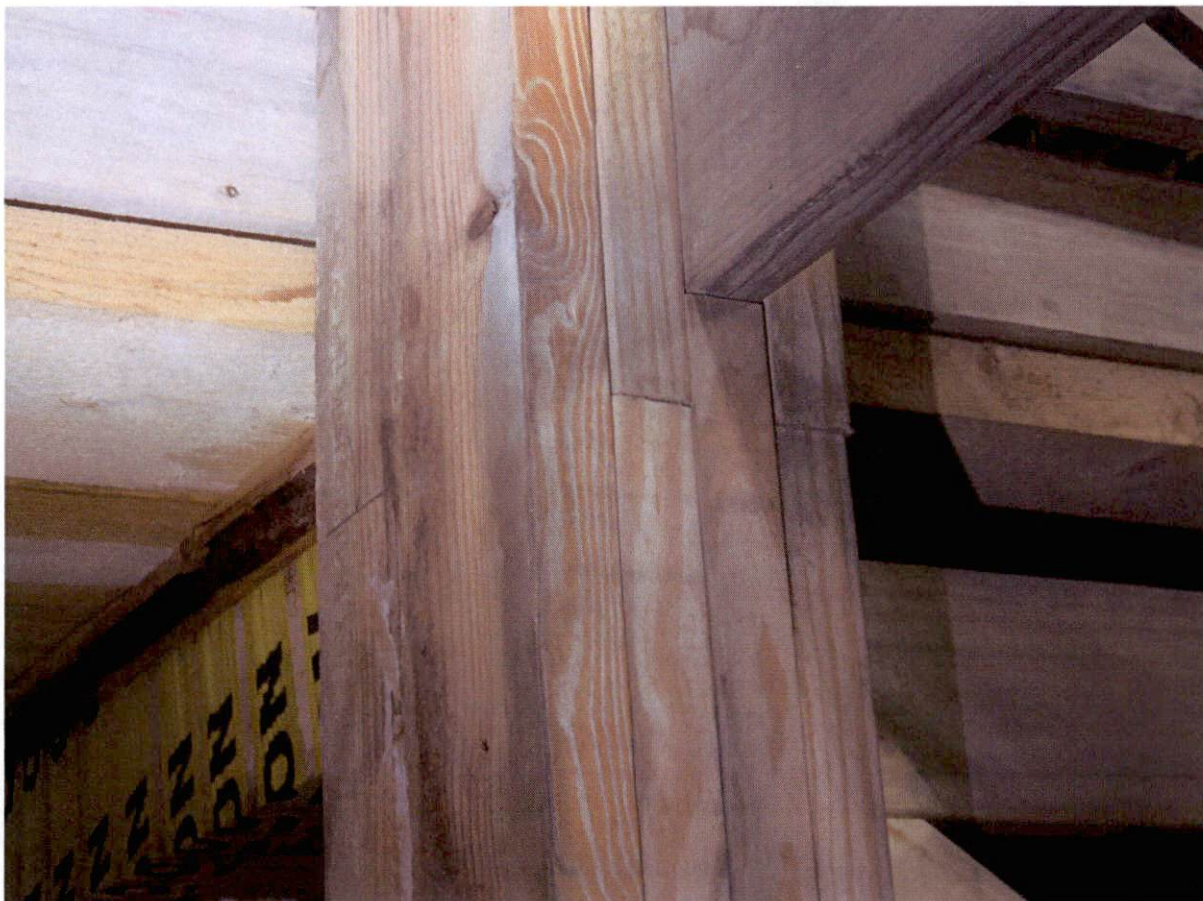
Unit 4 - Inappropriate location for built-up column joint

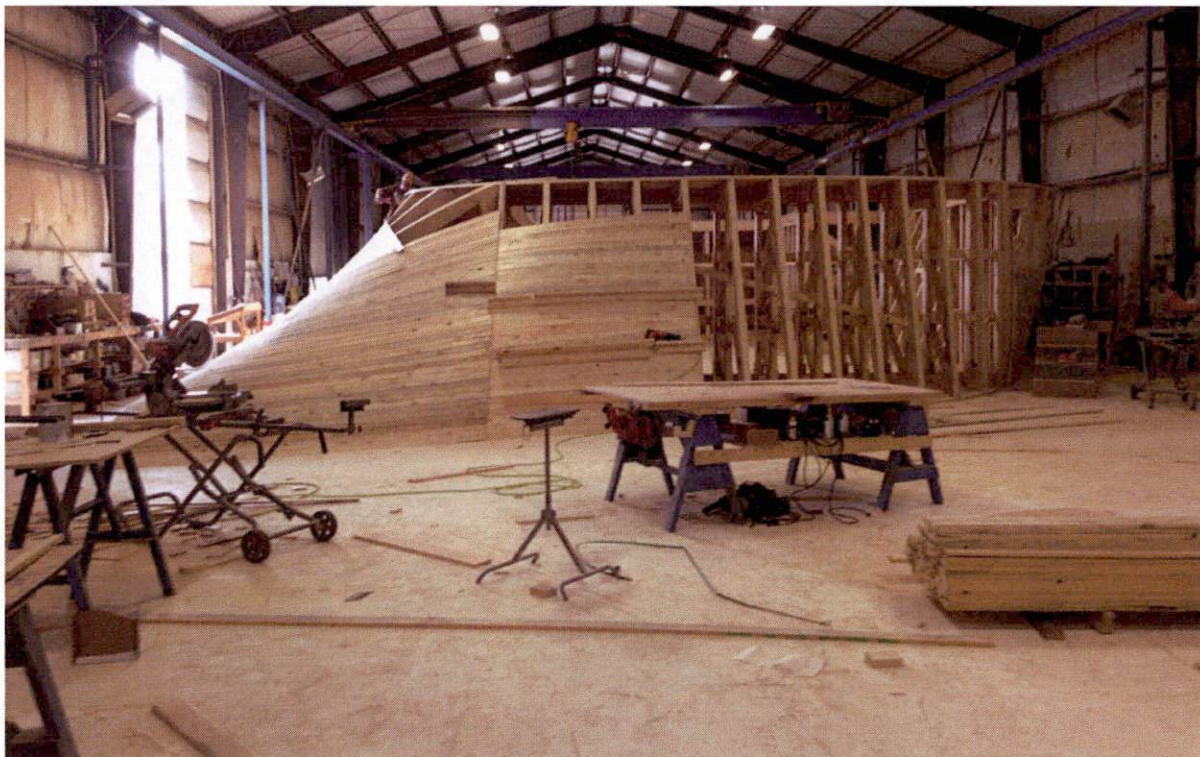
CEI Shop - Nalcor Visit
