# MEETINGS IN ST. JOHN'S AND VISITS TO LOWER CHURCHILL PROJECT SITES, JULY 11 TO 15, 2016

Prepared for: Natural Resources Canada and Nalcor Energy  
 IE Point of Contact: Nik Argirov  
 Date: November 2, 2016

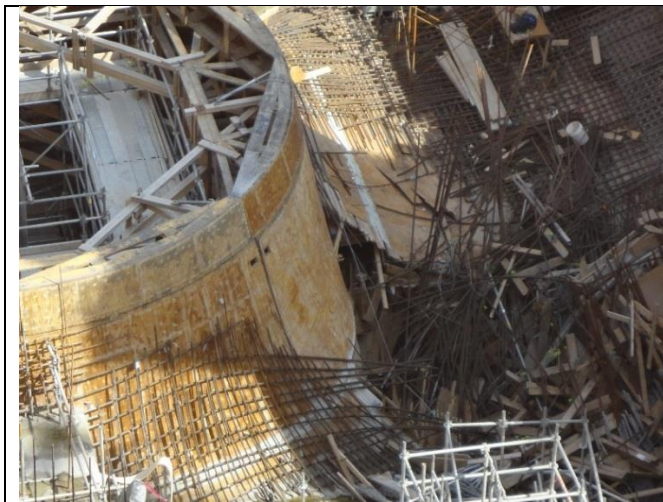
(a)

Photo C.11: Unit 2 formwork failure above draft tube (Photo 'a') and spilled concrete in the bottom of the draft tube area (Photo 'b'). (July 13, 2016)

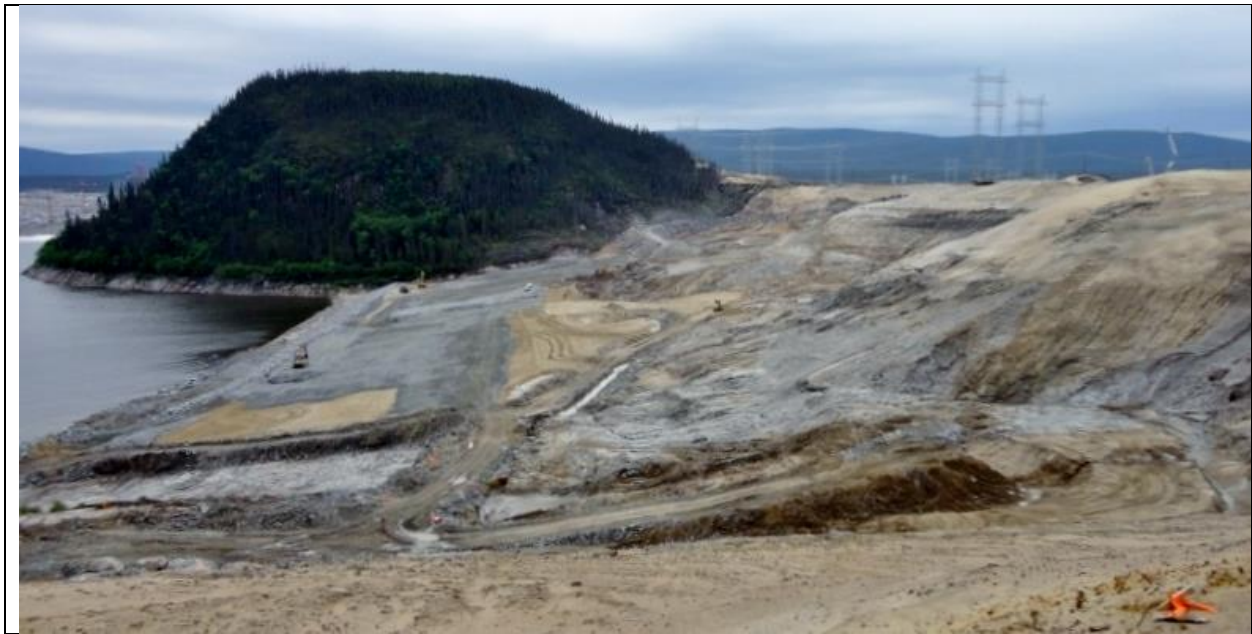
**Photo E.8:** North Spur, downstream slope. View long south. (July 14, 2016)
